HELMETTA DAM

NJ 00794

PHASE 1 INSPECTION REPORT
NATIONAL DAM SAFETY PROGRAM

REPT. NO: DAEN/NAP - 53842/NJ00794 - 81/08
AUGUST 1981

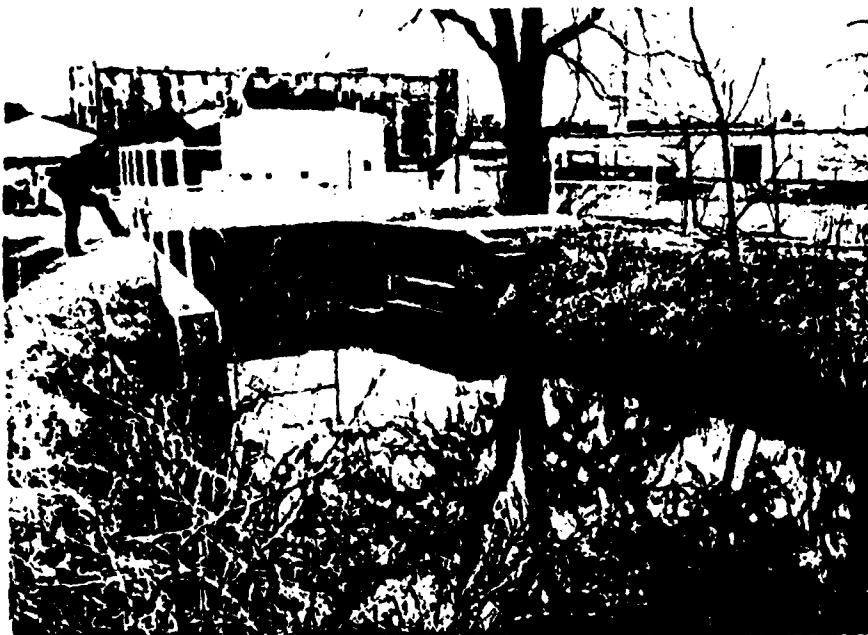
View from u/s looking into overflow channel at u/s end of pipe section spillway on left bank (circular cover at u/s end of pipe.)

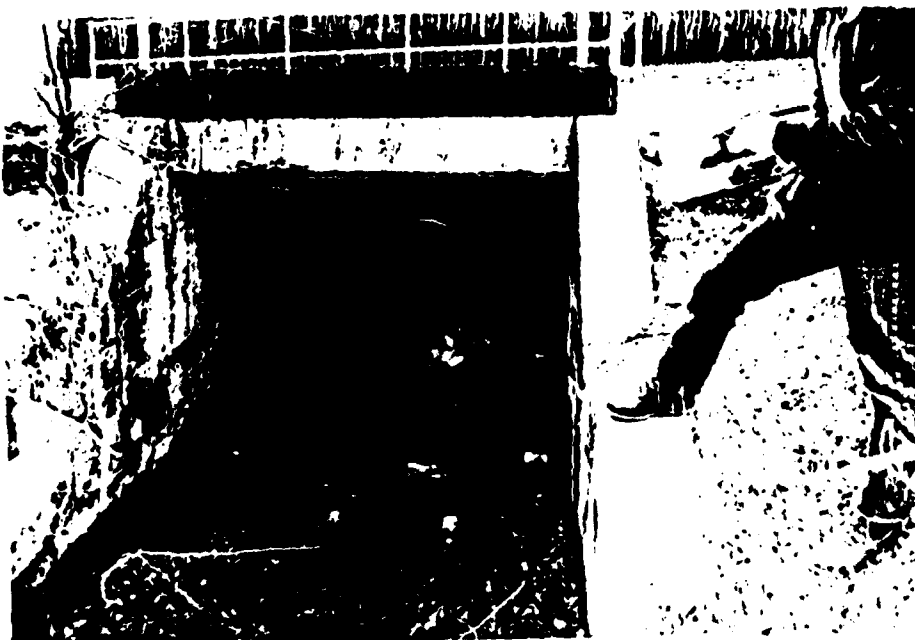
Looking u/s at d/s end of circular pipe spillway - note debris.
